Distal posterior humeral plating for periprosthetic humeral fracture in a female patient

A clinical case of a 70-year-old female patient with periprosthetic humeral fracture is reported. A new distal posterior humeral plate devised at our institution for nonunions and comminuted fractures of the distal humerus was used in the case. The treatment resulted in fracture healing and functional recovery of the limb at the pre-periprosthetic fracture level. Technical features of the fixator and surgical technique are described in details with cortical allograft practice used to augment thin cortical bone around the stem.

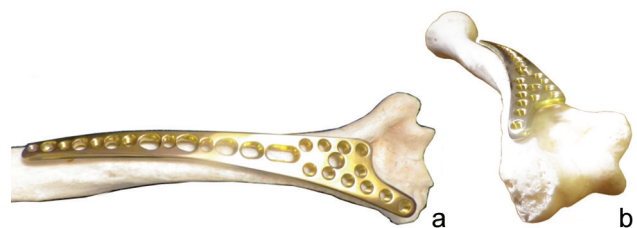
Posterior distal combined plate intended for fixation of the fractures and nonunions in the lower third humerus was developed at the RVSRITO within the context of governmental research assignments (Patent № 163085 dtd 10.10.16). The fixator (**Fig. 1**) is manufactured by Russian company «DC» and a component of a kit of figurate plates approved for clinical usage.

Fig. 1 Posterior distal combined plate attached to artificial humerus showing (a) back view; (b) view from the elbow joint

The plate is anatomically contoured in the posterior aspect of the humerus and supplied with sagittal curvatures, spirally spun to bypass radial nerve and avoid contact with the nerve. The diaphyseal part of the plate has intermediately sized compression holes for 3.5 mm and 4.5 mm cortex screws to be used according to specific patient anatomy. The holes alternate with 3.5 mm angle-fixed holes that are indicated to provide more stability for osteoporotic bone. The distal fixation incorporates a wider portion of the plate with humeral condyle attachment and eleven 3.5 mm angle-fixed holes for local osteoporosis in lower third nonunion.

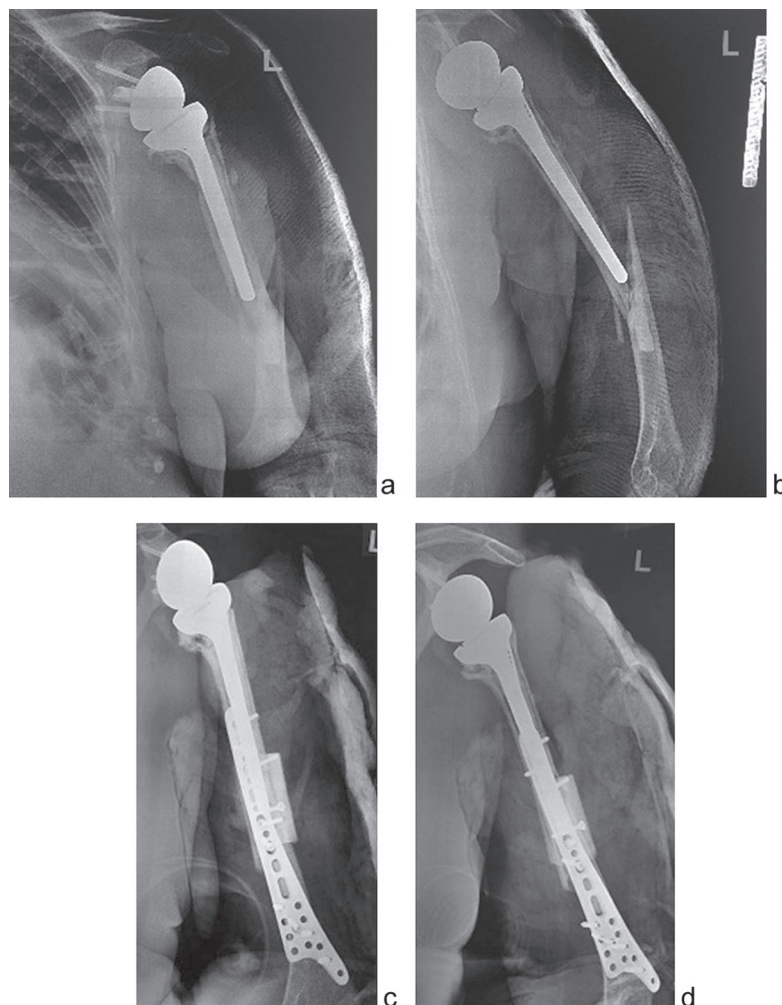
A 70-year-old female patient A., born 19.05.2015, presented at the RVS RITO with pathological mobility in the middle third of the left humerus, numb thumb on the left side with the absence of active extension. Her medical history included four-part fracture-dislocation of the proximal humerus on the left side she sustained due to fall from standing height in 2012. She had undergone a primary plating and re-plating of the left humerus via anterior transdeltoid approach at one of municipal hospitals. The treatments resulted in aseptic necrosis of the left humeral head, secondary deforming arthritis and rotator cuff degeneration and finally to poor function of the left shoulder and deficiency in active abduction. Total Neer C.S. score [10] was 26 indicating to a poor outcome. The DePuy Delta Xten™ reverse shoulder system was employed for total shoulder replacement procedure performed for the patient at the RVS RITO on 19.11.2012 with indications identified (**Fig. 2**).

Fig. 2 Radiographs of the left humerus of the 70-year-old female patient A. taken on admission at the RVS RITO on 19.05.2015 showing (a) anterolateral view, (b) lateral view after osteosynthesis, (c) postoperative AP view, (D) lateral view(inclined)

On 21.05.2015 periprosthetic humerus fracture was fixed with the plate and screws offered using bone allograft. The technology of the device suggests posterior approach. Intact radial nerve was visualised with the proximal and distal fragments exposed and the top of the humeral component poking out. Fixation of the humeral component in the proximal bone was assessed as stable. Then the distal combined plate was placed over bone fragments avoiding conflict with the radial nerve, and fixation screws bypassing the stem introduced. Cortical allograft with two cortex screws providing side-to-side compression for more reliable proximal stability was placed on the surface of the proximal humerus. The length of surgical intervention was 110 minutes with blood loss of 400 ml. Postoperative radiographs are presented in **Fig. 2 c, d**.

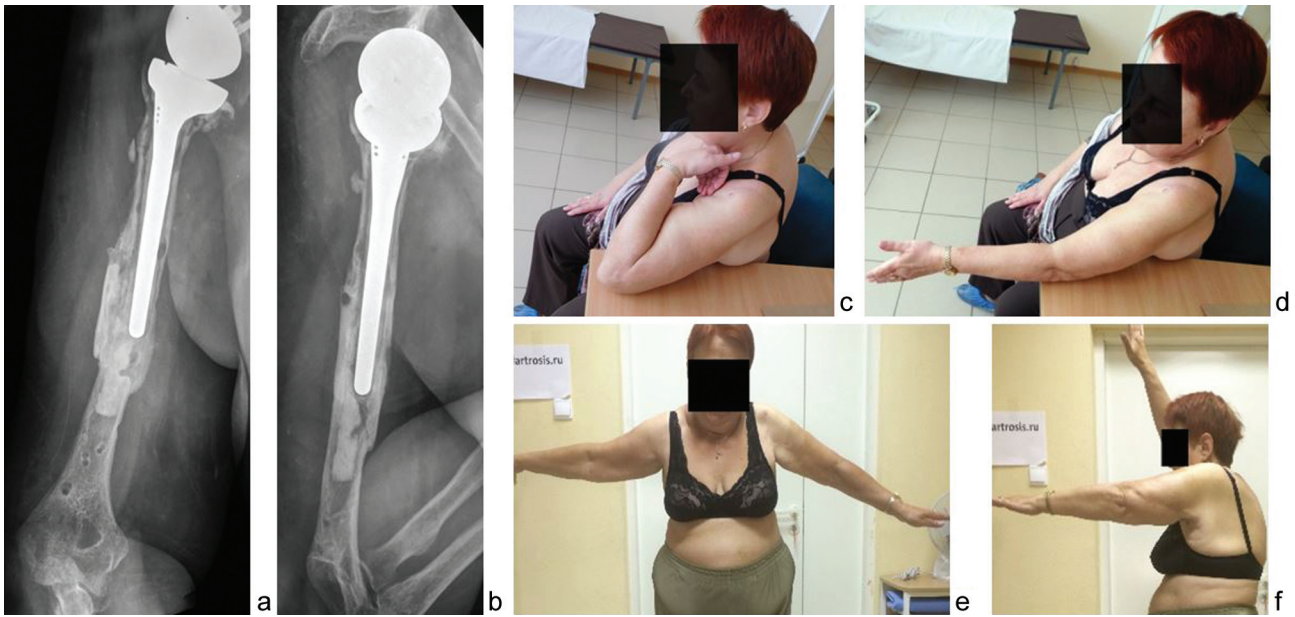
Functionally insignificant limitation in elbow extension by 15° with full flexion (**Fig. 3**) led to insignificant decrease in the Diasbility of the Arm, Shoulder and Hand (DASH) score of 35 points. Complete union of periprosthetic humerus fracture was seen on CT scan of 19.06.2016.

Fig. 3 Radiological and clinical appearance of the 70-year-old female patient A. at one year following fixation of the left humerus using the figurate plate offered and bone allograft (the fixator removed) showing (a) anteroposterior view, (b) lateral view, (c) flexion in the elbow joint, (d) extension in the elbow joint, (e) abduction in the shoulder, (f) extension in the shoulder
